Public Buildings Enhanced Energy Efficiency Program

Investigation Results For Department of Natural Resources

03/14/2012

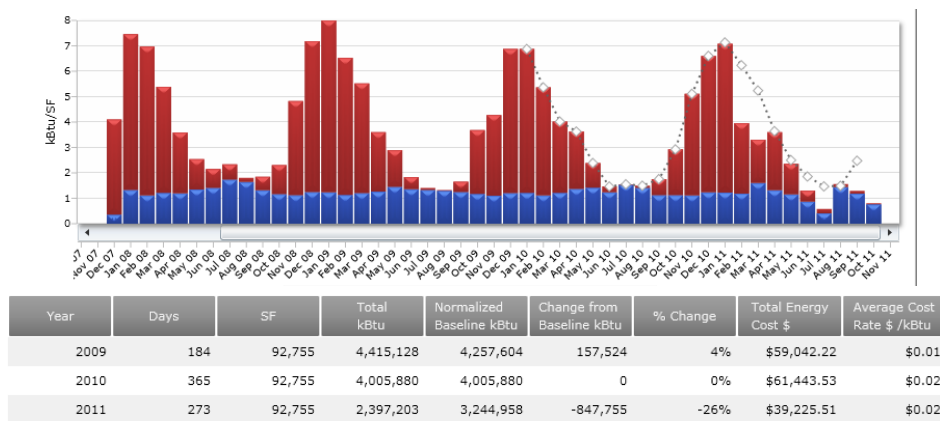
DNR Brainerd year to date energy use is down 26%

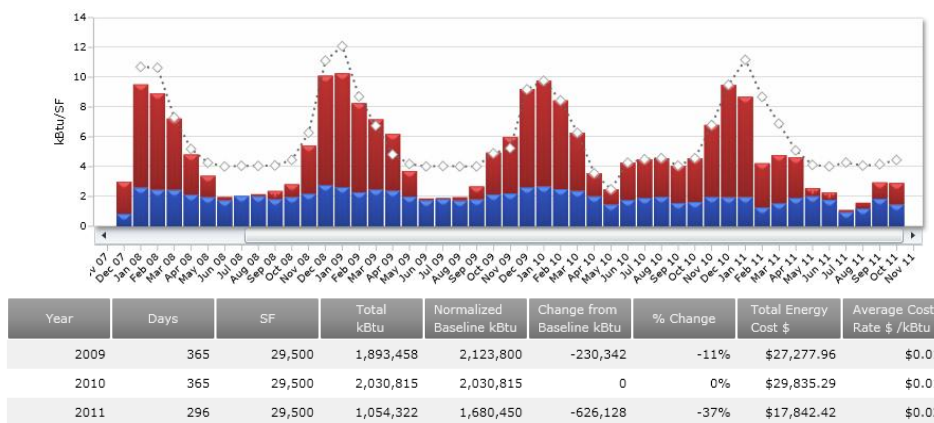
DNR Fergus Falls year to date energy use is down 37%

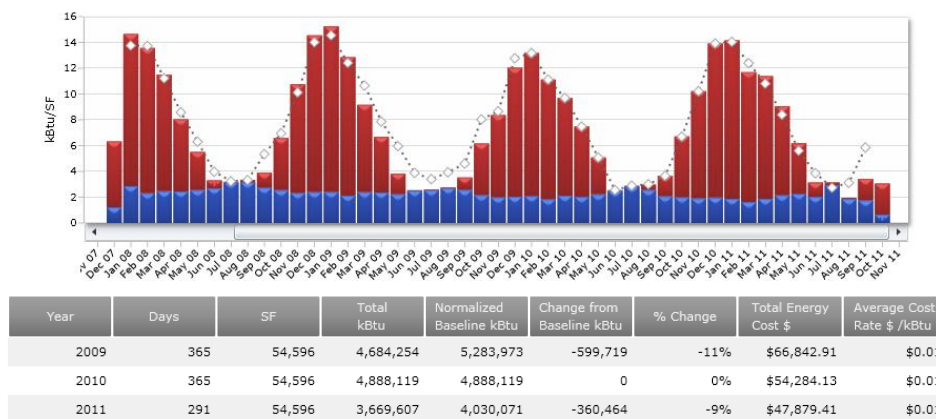
DNR Grand Rapids year to date energy use is down 9%
